Manhole Inspection Summary

Manhole # S43E__002MH

Record Plat: **43E** Node: **002** Status: **Found**

Insp Date: **4/23/08 9:07 AM**

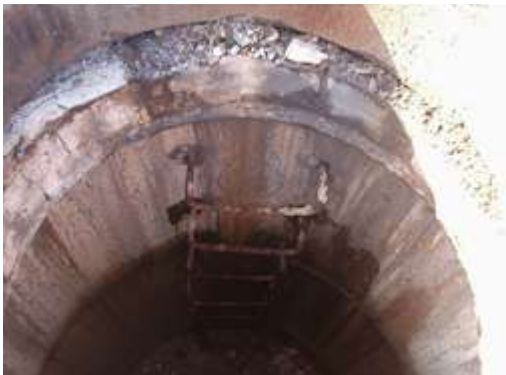
Defect 2

Condition: ☐ Sound ☐ Cracked ☐ Root Intrusion ☒ **Loose Brick** ☐ Deteriorated

Infiltration: ☐ None ☒ **Joint** ☐ Cracks ☒ **Mortar** ☐ Roots ☐ Wall

Loose Bricks

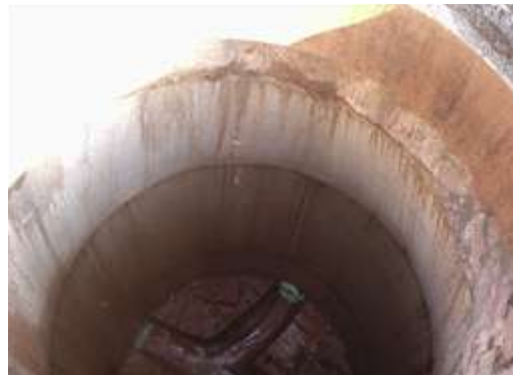
Defect 1

☒ **Leaks**

Frame Leaks

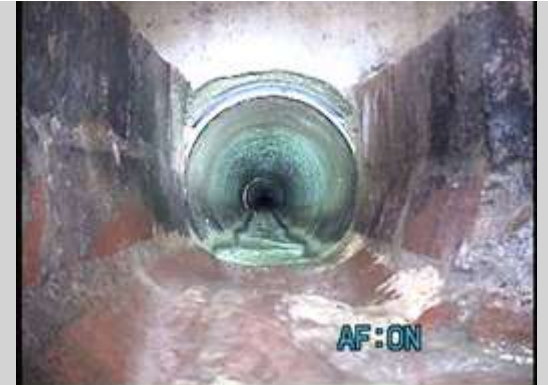
12 O'Clock Outflow

8 in. Circular Gravity Sewer
Pipe Out @ 12 O'Clock

Pipe Height: **8.4** (in.) Rod and Bar (Angled)
Pipe Material: **PVC** ☐ Pipe Lined
Invert Depth: **10.09** (ft.) Flow Characteristics: **Fast**
Deposits: ☒ None ☐ Mud ☐ Sludge ☐ Debris ☐ Grease
Silt Depth: (in.) Deposits Extent:
Infiltration: **None** Pipe Seal Cond: **Sound**

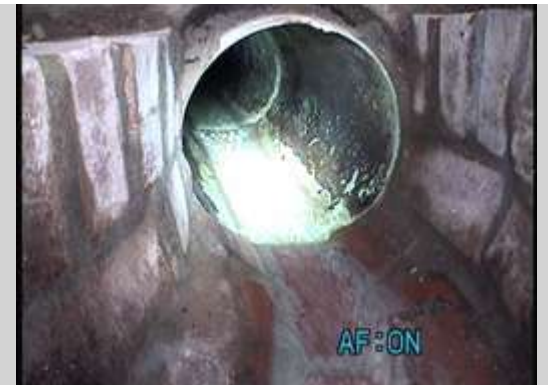
3 O'Clock Inflow

10 in. Circular Gravity Sewer
Pipe In @ 3 O'Clock

Pipe Height: **10.8** (in.) Rod and Bar (Angled)
Pipe Material: **PVC** ☐ Pipe Lined
Invert Depth: **10.05** (ft.) Flow Characteristics: **Fast**
Deposits: ☒ None ☐ Mud ☐ Sludge ☐ Debris ☐ Grease
Silt Depth: (in.) Deposits Extent:
Infiltration: **None** Pipe Seal Cond: **Sound**

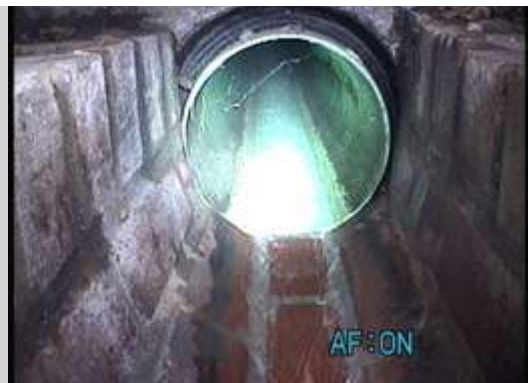
9 O'Clock Inflow

8 in. Circular Gravity Sewer
Pipe In @ 6 O'Clock

Infiltration: **None** Pipe Seal Cond: **Sound**
